Electrical Equipment Infrared Survey Project Proposal.

Client: ABC Company

AiturGroup Ltd Thermal Imaging /Infrared Survey Report.

**Thermography Inspection at
ABC Company.**

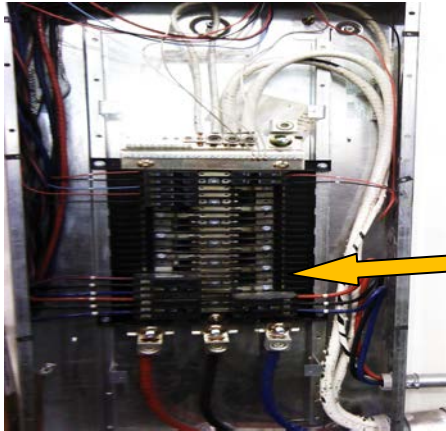
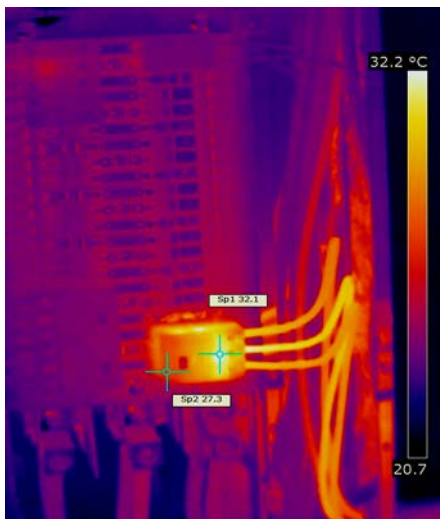
Location	Main Building
Equipment	Panel 4A, 120/208V, 400A
Type	Incoming lugs:120/208V
Nom/Rated Load	400 A
Actual Load :A	A=42; B=61;C=42
Type	Circuit Breakers:
Nom/Rated Load	CB # 38-40-42 3Phase;100A
Actual Load: A	A= 44A; Load %= 44 B =46A; Load %= 46 C= 40A; Load %= 40 Room Temp. C =23.5; Reflected Temp.=23.1 Rel. Humidity= 48.7% Emissivity= 0.95; Distance=2m
Fault	Fault Rating: 1: Low grade Spot1.Temp =32.1, Spot2=27.5; Tem. rise ΔT 4.6 °C, See IR picture.

Fault Suggestion: The $\Delta T < 5$ °C. However, the corrected maximum allowable temperature for the circuit breaker # 38-40-42 at the existing actual phase loads and room t °C is 29-30°C. The operating t°C=32.1
See calculation formula on the last page of the report.

3Phase CB # 38-40-42; Nominal rate: 100A. Actuals: A= 44A; Load %= 44; B =46A; Load %= 46; C= 40A; Load %= 40
Spot1.Phase B, Temp =32.1, Spot2=27.5; Tem. Rise ΔT = 4.6 °C. **Fault Rating: 1: Low grade.** See the suggestion above.
Recommendation: The CB to be monitored.

The 3Phase CB # 38-40-42 of the Panel 4A is found to be operating at a temperature of 32.1°C.

The actual operating temperature of the CB (32.1°C) is greater than the Tmaxcorr of 29.5°C.

This is an exception!

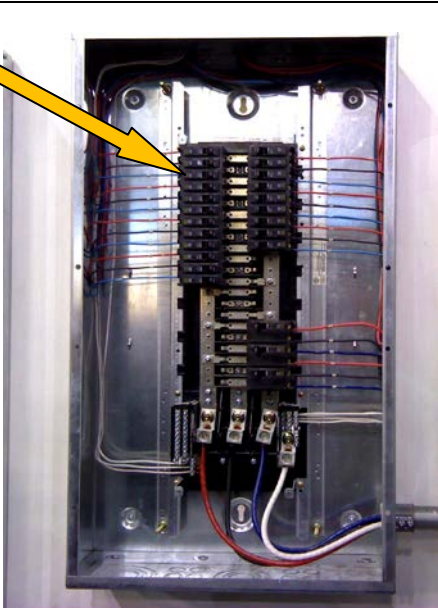
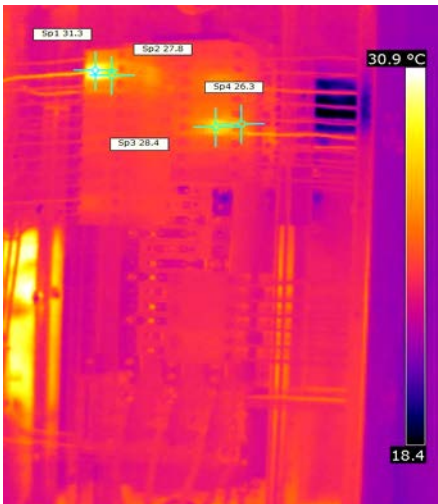
Location	Main Building
Equipment	Panel 2C, 120/208V, 225A
Type/Nom. Load	Main lugs-225 A
Actual Load:	A=1A; B=21A; C=23A Load unbalanced
Type	Circuit breakers
Nom/Rated Load	15 A
Actual Load	CB #3, Load=1A; Load %=6 CB #6, Load=4A; Load %= 26 Room Temp. C =23.5; Reflected Temp.=23.1 Rel. Humidity= 48.7% Emissivity= 0.95; Distance=2m
Fault	Fault Rating: 1: Low grade. CB #3; Spot1 t°C =31.3, Spot2=27.8; Tem. rise ΔT = 3.5 °C, CB #6; Spot3 t°C =28.6, Spot4=26.3°C; ΔT = 2.3 °C,

Fault Suggestion: CB# 3, the $\Delta T < 5$ °C. However, the corrected maximum allowable temperature for the circuit breaker # 3 at the existing actual load =1A and room t °C is 23-24°C. The operating t°C=31.3
See calculation formula on the last page of the report.

Fault Rating: 1: Low grade. See the fault suggestion above.
Incoming lugs phases loads somewhat **unbalanced** at A=1A; B=21A; C=23A
Recommendation: the CB # 3 to be monitored.

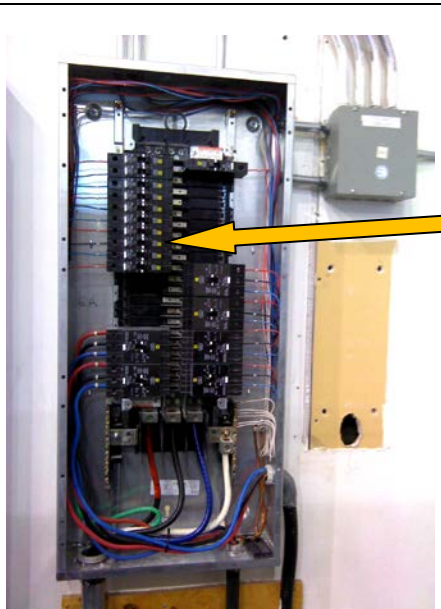
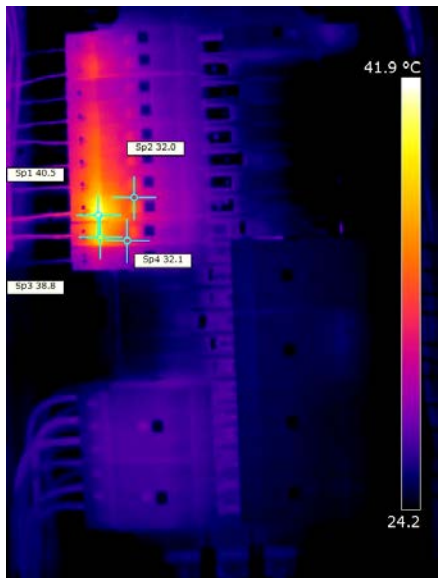
Location	Main Building
Equipment	Panel 6A, 347/600V, Rated :250A Actuals=66A;B=73A;C=70A
Type	Circuit breakers
Nom/Rated Load	15 A
Actual Load	Circuit Breaker #15 Load = 11A; Load %= 73 Spot1 t°C =40.5, Spot2=32.0; Tem. rise ΔT= 8.5 °C Circuit Breaker #17 Load = 11A; Load %= 73 Spot1 t°C =38.8, Spot2=32.1; Tem. rise ΔT= 6.7 °C
Fault on: CB# 15 and CB#17	Fault Rating: 1 Low grade Room Temp. C =23.5; Reflected Temp.=23.1 Rel. Humidity= 48.7% Emissivity= 0.95; Distance=2m See IR picture.

Circuit Breaker #15, Tem. rise $\Delta T = 8.5 \text{ }^\circ\text{C}$; Circuit Breaker #17 Tem. rise $\Delta T = 6.7 \text{ }^\circ\text{C}$. **Fault Rating: 1 Low grade.**
Recommendation: the CB # 15 and CB# 17 to be monitored.
